# Brittle Stress Cracking of HDPE Geomembrane caused by Localized Over-Heating of Fusion Wedge Welds

A. L. Marta, Red Earth Engineering, Brisbane, Queensland, Australia

This paper presents the results of an investigation carried out on a geomembrane lined pond in Australia which was temporarily decommissioned due to elevated leakage rates and observed development of geomembrane 'whales', after it was in service for only 4 years. The investigation identified a number of geomembrane cracks (or splits) in the vicinity of the whales. The cracks were orientated parallel to the outside edges of fusion wedge weld tracks where adjoining geomembrane panels were seamed. A 400 mm long crack was exhumed and analysed in the laboratory. The testing confirmed the heat affected zone adjacent to the crack was more susceptible to brittle stress cracking compared a control sample, and exhibited raised crystallinity which is indicative of higher than industry standard welding temperatures and slower cooling. It is hypothesized that failure of the geomembrane occurred at the edges of fusion wedge weld tracks due to the combined effects of 1) raised crystallinity from unacceptably high welding tempera

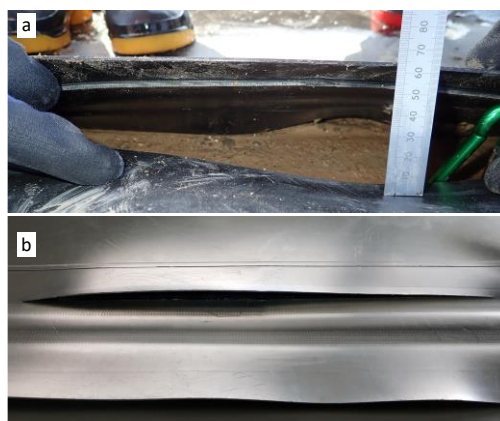
A number of geomembrane cracks (or splits) were identified in the vicinity of the whales. The cracks were orientated parallel to the outside edges of fusion wedge weld tracks where adjoining geomembrane panels were seamed. The heat affected zone of a weld adjacent to a 400 mm long crack was analysed in the laboratory to assess the causes of the geomembrane cracks. The geomembrane cracks were repaired in situ and the impact on leakage rates was assessed after the pond was recommissioned. The lessons learnt from the investigation are presented in this paper. This paper also demonstrates that the use of Action Leakage Rates (ALRs) are an effective tool for pond operators to assess the performance of the geosynthetic lining system, by comparing the monitored leakage rates with the calculated ALR, which then informs appropriate remedial actions to be taken in the event of the ALR being exceeded.

ID	Description	Photographs
Defect 1	50 mm long dent. Possible tool mark. Does not penetrate full thickness of geomembrane	
Defect 2	200 mm long extrusion weld on fusion weld seam. The extrusion weld penetrated the full thickness of geomembrane	
Hole 1	400 mm long split concealed beneath the overlap of fusion welded panels	Figure 1
Hole 2	60 mm long split concealed beneath failed extrusion weld	Figure 2
Hole 3	>500 mm long split concealed beneath the overlap of fusion welded panels	Figure 3

Figure 1. Photograph of Hole 1: a) top side; b) bottom side

- 1) The defect or hole was cut out from the geomembrane. The cuts extended a minimum 150 mm past the edges of the defect or hole. Corners of the cuts were rounded with a smooth radius to minimize points of potential stress concentrations
- 2) The surface of the geomembrane was thoroughly cleaned using dry rags
- 3) The patch was temporarily bonded to the existing geomembrane using a heat gun and hand-rolling tool (see Figure 6a)
- 4) The perimeter of the patch (i.e. the area of geomembrane to be covered by the extrusion weld) was ground using an abrasive tool (i.e. angle grinder) to roughen the surface and remove potential contaminants (see Figure 6b)
- 5) The patch was bonded to the existing geomembrane using an extrusion fillet (see Figure 6c).

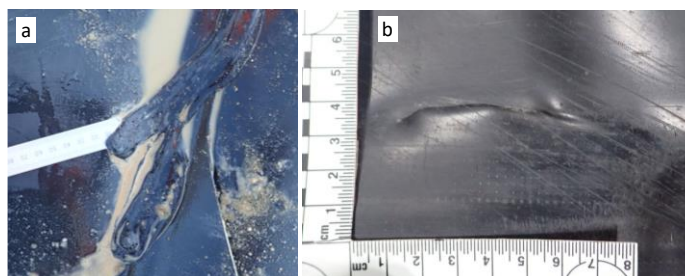
Figure 2. Photograph of Hole 2: a) top side; b) bottom side

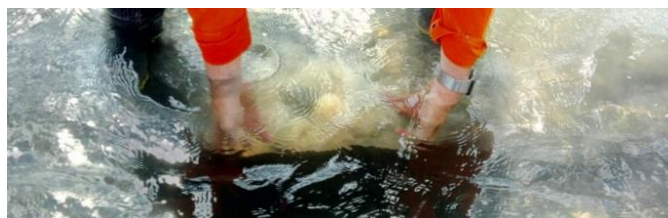
Figure 3. Photograph of Hole 3

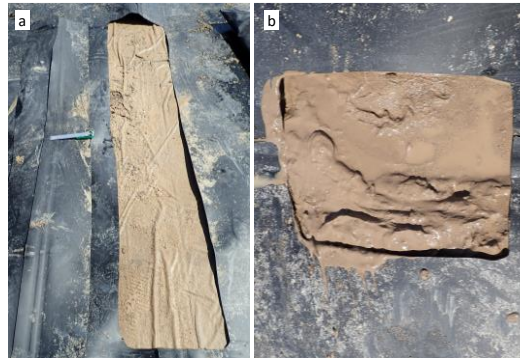
1. Some areas of the pond floor are not suitably graded towards the leakage discharge pipe; hence water was observed to be trapped beneath the geomembrane and the subgrade
2. Some areas of the upstream batters had water trapped beneath the geomembrane, as the ballast tubes positioned at the toe of the batters appeared to be preventing the water from flowing freely to the pond floor
3. The subgrade is generally undulating with localised depressions and raised mounds
4. The subgrade has been saturated and softened at localized areas due to leakage through the geomembrane holes

Photographs showing the condition of the subgrade at the locations of Hole 1 and Hole 2 are presented in Figure 4. Dynamic Cone Penetration testing suggests the wetting front of the leakage water penetrated the subgrade up to 0.5 m depth.

Figure 4. Inspection of subgrade at locations: a) Hole 1; and b) Hole 2.

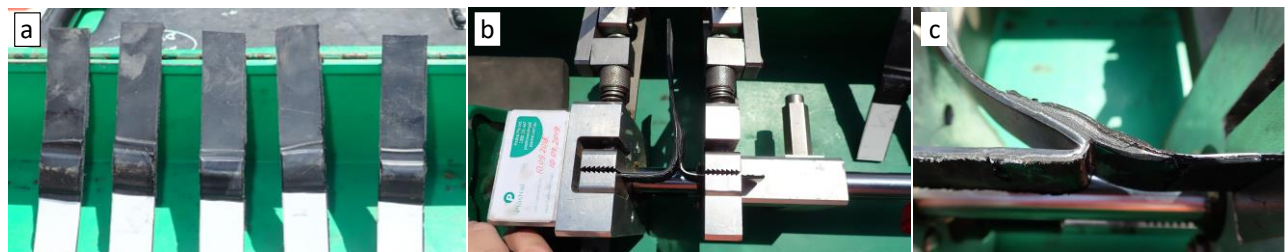
Prior to undertaking geomembrane repairs, trial welds were performed on site using scrap pieces of geomembrane for quality control purposes (i.e. to establish weld machine settings of temperature, pressure and travel rate under actual site conditions, as well as establishing procedures to be followed by the welding technician). Coupons of 25 mm width were extracted from the trial welds and were subjected to peel and shear strength testing on site using a tensiometer, in accordance with the requirements of GRI GM19. Photographs of the trial weld coupons and the field testing are shown in 5.

Figure 5. Photographs of trail weld field testing: a) prepared test coupons; b) peel test in the tensiometer; c) close up view

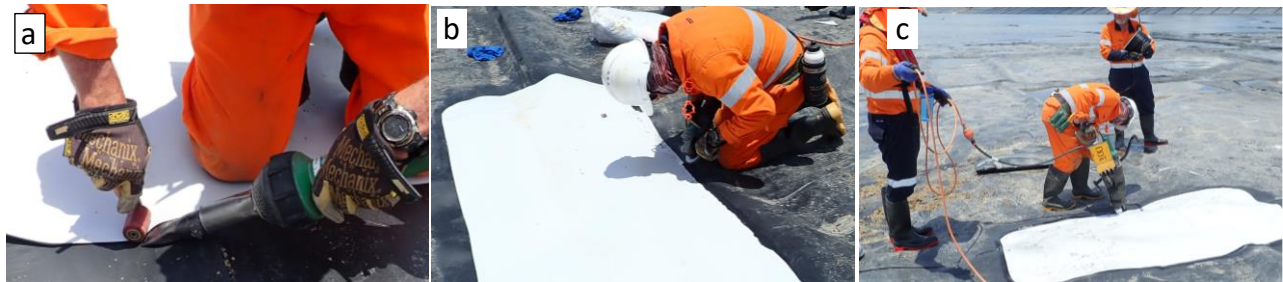
Figure 6. Photographs showing the sequence of patching: a) temporarily heat bonding; b) grinding; c) extrusion welding

All repairs were undertaken using extrusion weld patches. The patches comprised 2 mm white high-performance HDPE geomembrane manufactured from the same resin type as the installed geomembrane. The white geomembrane was selected for the repairs to provide a visual contrast from the black geomembrane, making their locations easy to identify for future monitoring and inspections. The general procedure for undertaking the patch repairs involved the following:

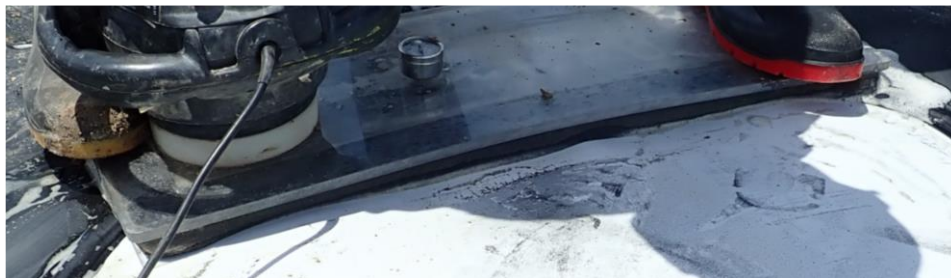
The extrusion welds for repair patches were visually inspected to assess the quality of the weld. This included observations of the weld width, thickness and geometry of the track marks. The extrusion welds were also subjected to vacuum box testing over the entire length of the seam (see Figure 7). The procedure for the vacuum box testing is as follows:

- 1) A soapy solution was applied over the seam
- 2) The vacuum chamber was placed on top of the seam and firmly held in position to ensure a perimeter seal
- 3) A negative (suction pressure) was applied to the chamber and held for a minimum of 10 seconds. During the suction, the seam was visually inspected through the clear walls of the vacuum chamber to assess whether air is flowing through the seam.

Figure 7. Photograph of vacuum box test

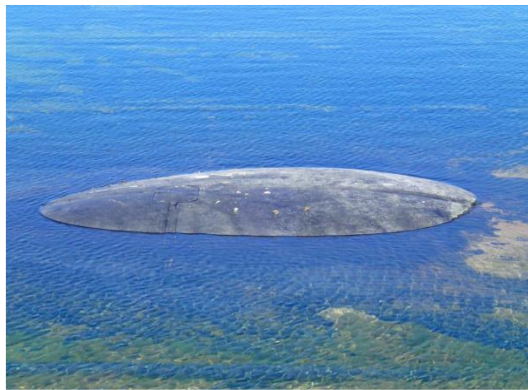
Geomembrane whales developed on the pond floor while the pond was in service. Whales are bubbles of air (or other types of gas in some cases) that develop under the geomembrane, and appear as 'whale backs' above the surface of the water, exerting out-of-plane stresses in the geomembrane. Once initial geomembrane deformation occurs, the air tends to concentrate in localized areas beneath the geomembrane, causing the whale to grow over time. It is possible for whales to cause bursting failure of the geomembrane. A photograph of a typical whale in the pond is shown in Figure 8 and Figure 9. There are many possible causes of whales, including:

- 1) Trapped air during construction which has not been expelled
- 2) Air is potentially entering at geomembrane hole locations
- 3) A lower possibility could be leakage through geomembrane, which has infiltrated the underlying subgrade, expelling the pore air in the soil. The expelled pore air has migrated to the surface of the subgrade, and has become trapped beneath the geomembrane.

Figure 8. Photograph of typical geomembrane whale in pond

The whales were 'walked out' towards the batters where air vents are located. Ballast tubes installed at the toe of the batter were also removed at selected locations to allow the whales to be transmitted to the air vents.

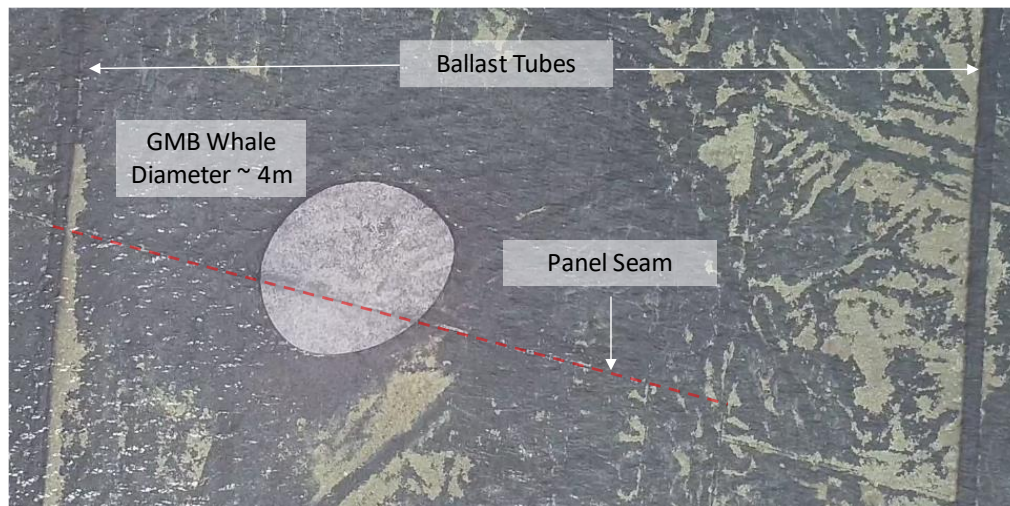
Figure 9. Aerial photograph showing location of whale relative to ballast tubes and geomembrane panel seam

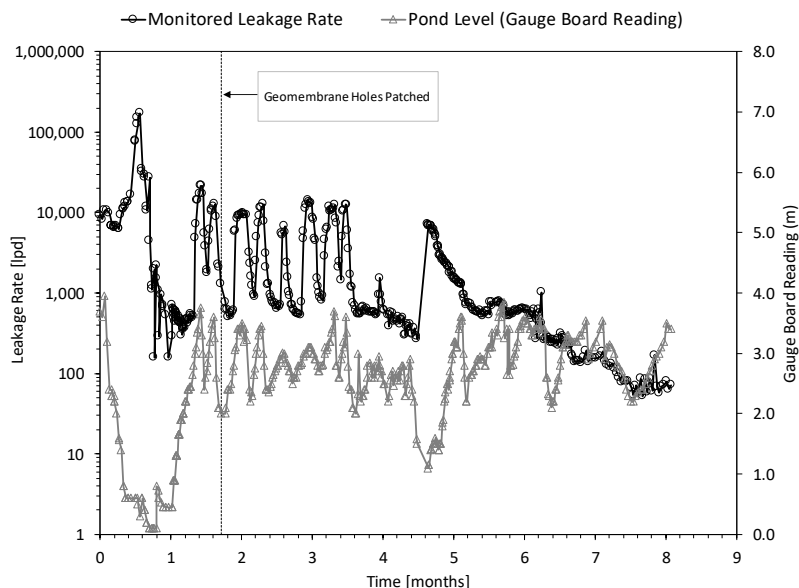
During the first three days of monitoring, the leakage rate was approximately 10,000 lpd. The water level in the pond was then reduced by nearly 4 m following the three days of monitoring. Counterintuitively, the leakage rate rapidly increased from 10,000 lpd to over 100,000 lpd as the water level was lowered. According to leakage theory, the leakage rate is expected to reduce when the water head on the geomembrane is reduced. After the leakage rate peaked at over 100,000 lpd when the pond was emptied, it steadily reduced to less than 1,000 lpd. The fact that the leakage rate did not approach zero when the pond was empty indicates that not all the water trapped beneath the geomembrane was released before the pond was re-filled.

The observed increase in leakage rate that occurred during the lowering of the water level may be explained by the combination of water trapped beneath the geomembrane and the loss of what is referred to as 'intimate contact'. The term intimate contact is associated with a composite liner system comprising two complementary components: the geomembrane and layer of low permeability soil (or in some cases, a bentonite geocomposite). When the two components of the lining system are in intimate contact, leakage through a hole in the geomembrane is reduced due to the presence of the low permeability layer beneath the geomembrane. In liquid containment facilities, intimate contact between the geomembrane and the underlying soil is improved when the weight of the contained liquid applies a pressure above the geomembrane. In other words, a composite liner should always be loaded to achieve composite action.

When filling commenced, a clear hydraulic connection between the impounded water and the discharge pipe is observed for approximately 2.5 months, which is indicative of large holes in the geomembrane. The leakage rate responds almost immediately with only a very small time-lag with respect to changes in water level. That is, an increase in water level corresponds to an increase in leakage rate; while a decrease in water level corresponds to a decrease in leakage rate.

Figure 10. Plot of leakage rates and pond level against time

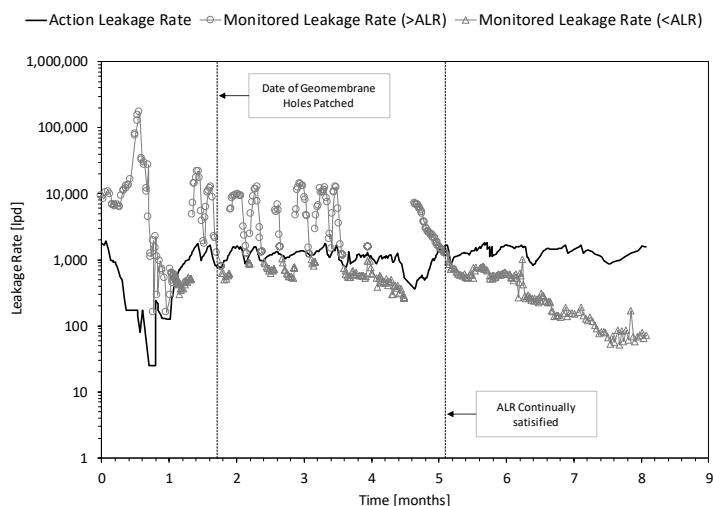
Action leakage rates were calculated based on theoretical leakage equations (Giroud, 1997) and published data relating to the frequency and size of holes in HDPE geomembranes which are installed with strict construction quality assurance and electric liner integrity surveys (Giroud, 2016). The graph of action leakage rate (as a function of hydraulic head) plotted against time is provided in Figure 11. Included on the same figure is the monitored leakage rate for direct comparison with the action leakage rate.

After the geomembrane holes were patched and the pond was returned to service, it took approximately 3 months before the monitored leakage rate dropped continuously below the action leakage rate. This lag time may be attributed to the fact that the leakage rate did not approach zero when the pond was empty, which indicates the flow of trapped water beneath the geomembrane was contributing the leakage rate after the geomembrane was repaired.

Figure 11. Plot of action leakage rate and monitoring data against time

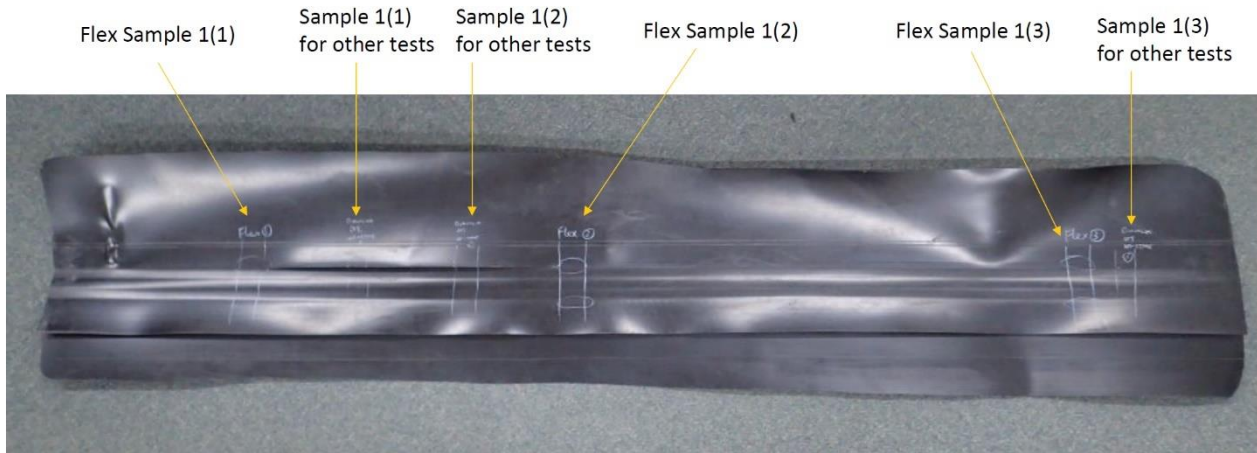
Geomembrane specimens were prepared from the 'Hole 1' geomembrane sample as shown in Figure 12.

Figure 12. Photograph of 'Hole 1' sample outlining specimen locations

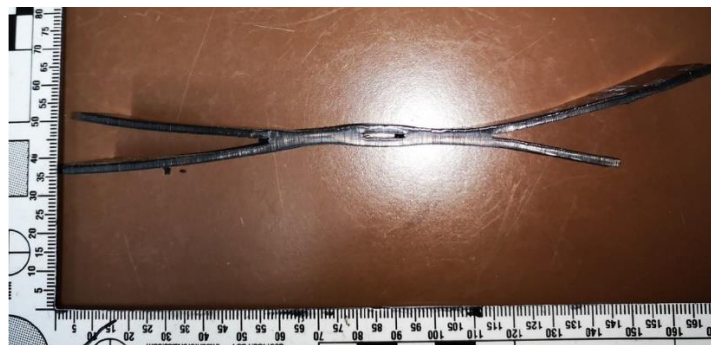
The weld profile of each specimen was measured using calibrated digital Vernier calipers. The results of the measurements are summarized in Table 2, and shows there is a thick-thin transition that occurs across the weld profile (a pronounced geometric effect leading to a stress concentration). A photograph of a weld profile is shown in Figure 13.

Dimension (mm)	1(1)	1(2)	1(3)
Thickness of liners	3.93	3.91	3.93
Thickness of seam	3.54	3.49	3.55
Seam reduction thickness	0.39	0.42	0.38
Air channel width	8.72	8.37	8.96
Weld width	11.8	11.8	12.2
Width of squeeze out bead	4.81	4.88	4.98

Figure 13. Photograph of weld profile (specimen 1(3) shown).

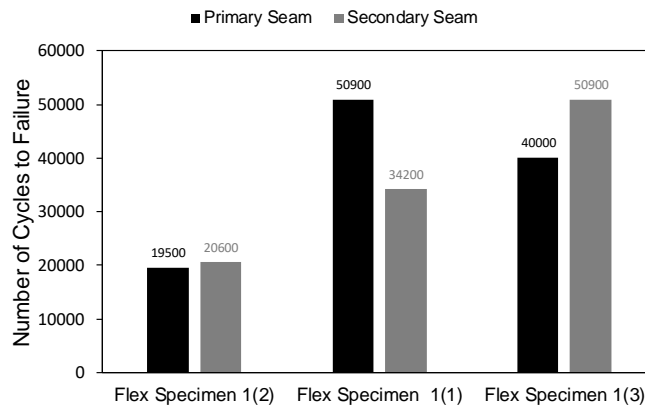
The primary and secondary seams of specimen were subjected to flexural cycle testing using an accelerated flex-life apparatus. The results are shown in Figure 14

, which indicates the weld track located closest to the crack is more susceptible to brittle stress cracking than the weld track located further away from the crack. The weld track closest to the crack fails with far less flex cycles, and fails directly on the edge of the weld track as was the case in the field failure. The weld track further from the crack fails with ductile behavior, and the failure occurs several centimeters away from the edge of the weld track.

Figure 14. Results of flexural cycle testing

Laboratory flex testing using the accelerated flex life apparatus has confirmed that the fusion weld at 'Hole 1' is more susceptible to stress cracking than the weld located 400 mm further away from the edge of the hole, where the failure mode is more ductile.

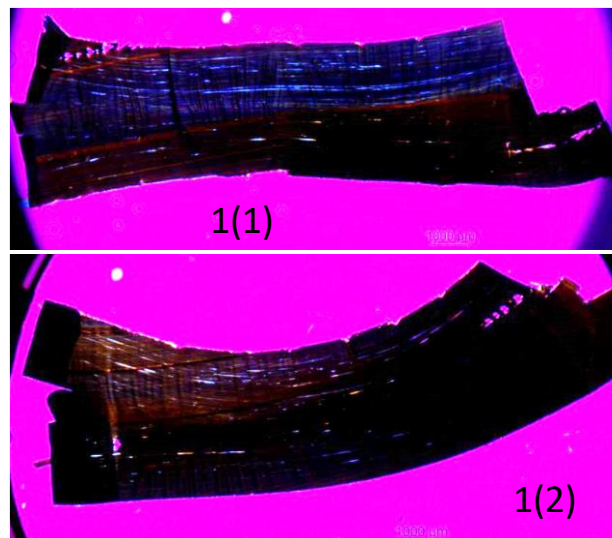
The weld interfaces of specimens 1(1) and 1(2) were examined using light transmission microscopy, shown in Figure 15.

Figure 15. Weld interface light transmission microscopy examinations polarized with lambda plate

The other factors that have contributed to the observed brittle failure of 'Hole 1' are raised crystallinity on the edge of the weld (in the heat affected zone) - usually due to slow cooling - and also the thick-thin transition that occurs across the weld profile (a geometric effect). When all three factors occur in the field, namely; the raised crystallinity, the geometric stress concentrating feature (which is inevitable with fusion welds) and the cyclic stresses imposed by whales, brittle cracking is likely to occur directly at the edge of the weld track.
