Durability characterizing of woven geotextiles container system

J.L.E. Dias Filho, Department of Civil Engineering, Darcy Ribeiro State University of Northern Rio de Janeiro (UENF), Campos dos Goytacazes, Brazil, jlernandes@hotmail.com
P.C.A. Maia, UENF, Campos dos Goytacazes, Brazil, maia@uenf.br
G.C. Xavier, UENF, Campos dos Goytacazes, Brazil, gxavier@uenf.br

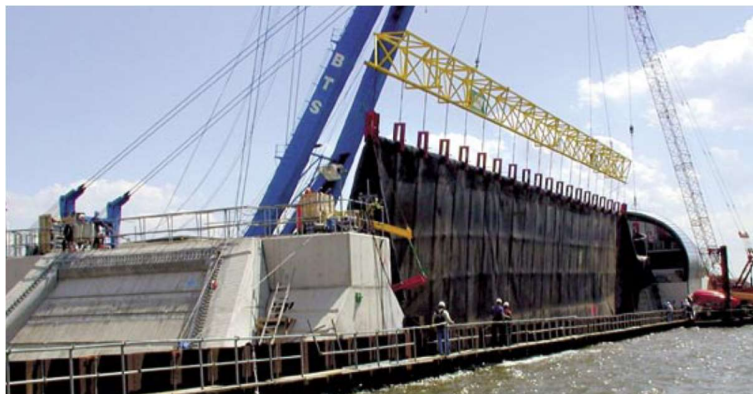
(a) storm barrier consisting of geomembrane

Perrier (1986), Sehgal (1996) and Jongeling and Rovekamp (1999) describe the Delta Project. According to the authors, to protect the West coast of Overijssel, a province of the Netherlands, against flooding of Lake IJsselmeer and the Ketelmeer River, a storm barrier consisting of geomembrane was constructed (Figure 1a). The material used for filling was a combination of air and water by means of insufflation. This minimized the GCS dimensions and also allowed the dam height to be adjusted quickly as needed (Figure 1b). The protective barrier of that region was composed of three GCS and the projected dimensions were: length 75 m, width 13 m and height 8.35 m (Figure 1c).

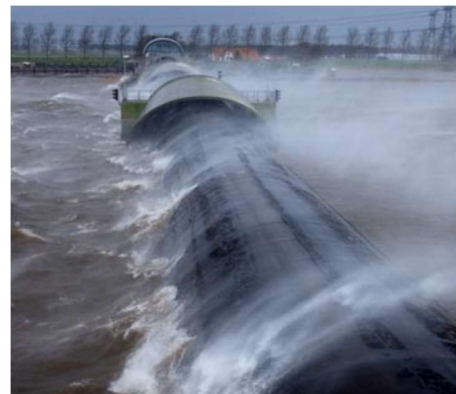
(b) GCS inflated

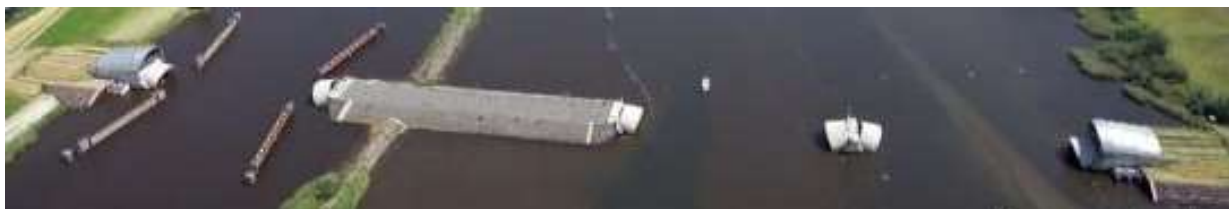
Figure 1. Delta Project (from Sehgal 1996 and Jongeling and Rovekamp 1999)

(c) Overijssel region with the location of the three GCS with 75 m

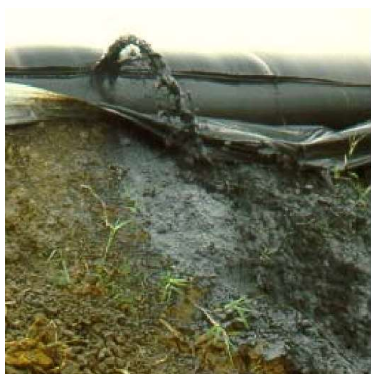
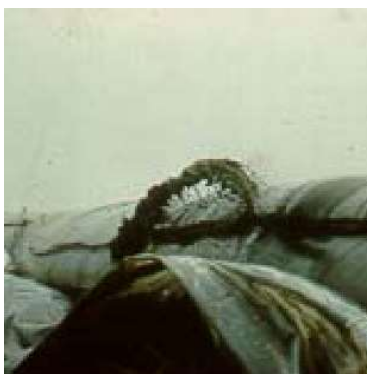
(a) local rupture – overview¹

(b) local rupture – detail¹

Leshchinsky et al. (1996) show, in Figure 2a and 2b, a break in the seam of a GCS in the city of Mobile, Alabama, and Kunz et al. (2014) detail the navigable canals of Midland, Germany, which underwent interventions and that, during the drought, GCS displacement was observed (Figure 2c). The most severe case was found in the canal surface layers, with more severe damage present (Figure 2d). Figures 2e and 2f by Alvarez et al. (2007) and Shin and Oh (2007) exhibit a typical long-lasting effect on breakwaters by seaweed. In Figures 2g and 2h, Bruscas (2015) cites GCS damage off the Ocean Shore, California, which is impacted by many beach surfers and heavy storms.

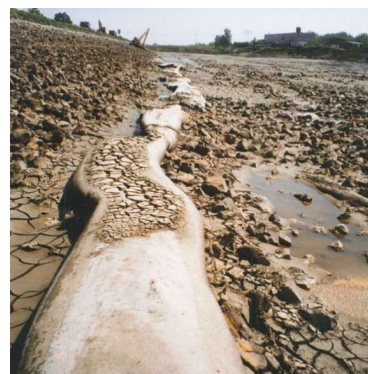
(c) displacement²

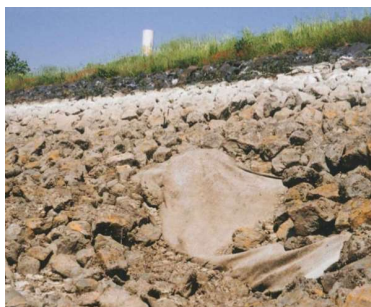
(d) cracked²

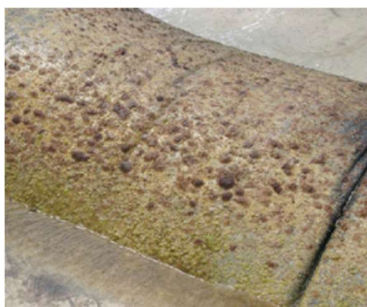
(e) seaweed³

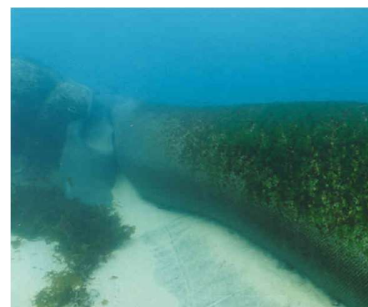
(f) marine flora and seaweed⁴

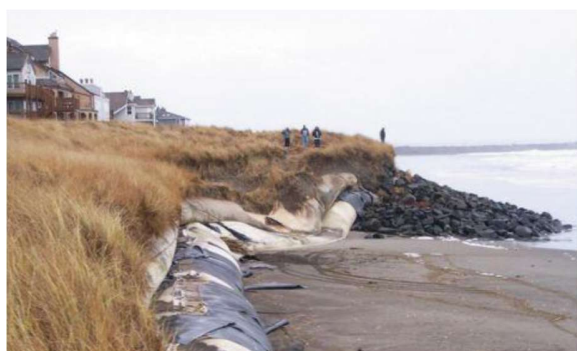
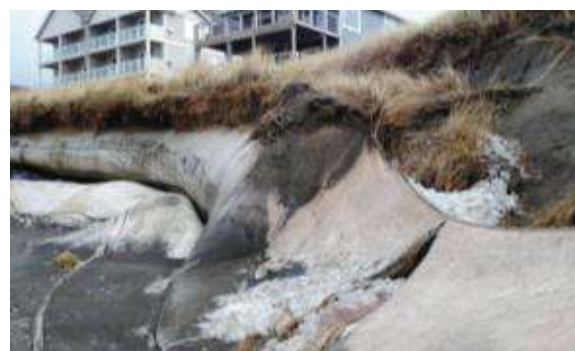
Figure 2. General occurrences of GCS problems (from ¹Leshchinsky et al. 1996; ²Kunz et al. (2014); ³Alvarez et al. (2007); ⁴Shin and Oh (2007) e ⁵Bruscas (2015))

(g) damage – overview⁵

(h) damage – detail⁵

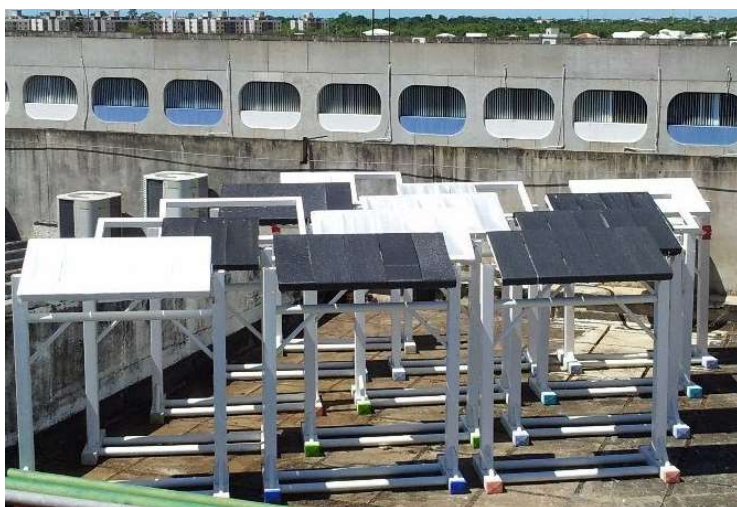
(a) Outdoor exposure

The samples were exposed to the natural climatic conditions in Campos dos Goytacazes/RJ from August 2013 to August 2015 (Figure 4a). The samples were installed on the support which has an inclination of 21°48' degrees in relation of the horizontal which correspond to the local latitude, 21° 48' 14" S and 41° 19' 26" W. This procedure ensures a higher incidence and, consequently, greater absorption of solar radiation by the material. It was used the ISO TS 13434 and ASTM D5970. The degradation times in the field to be subjected to the tests set out in the experimental program were 90, 180, 270, 360 and 720 days.

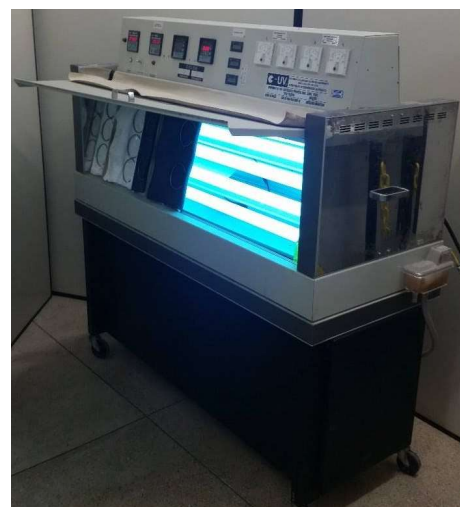
Figure 4. Geosynthetics in degradation process in field and laboratory.

(b) Accelerated UV test

The samples were degraded by condensation and ultraviolet radiation (Figure 4b), which simulates the natural changes throughout the temperature variation between day and night; precipitation and UV radiation by the sun. The conditions replicate well the natural degradation process because they simulate with greater intensity the main mechanism of degradation in geosynthetics used in geotechnical design.

The degradation times accelerated in the laboratory to be subjected to the tests set out in the experimental program were 8, 16, 24, 32, 40, 80, 200, 400, 800, 1040, 2160 e 4800 hours. UVB lamps and ASTM D4355 guidelines were used. The UVB lamps disponsible at laboratory give a short wavelength output in comparison to field exposure, but promote the degradation of materials quickly.
