Geomembranes – From Design to Handover and Some Case Histories

A. L. Marta, Red Earth Engineering, Brisbane, Queensland, Australia

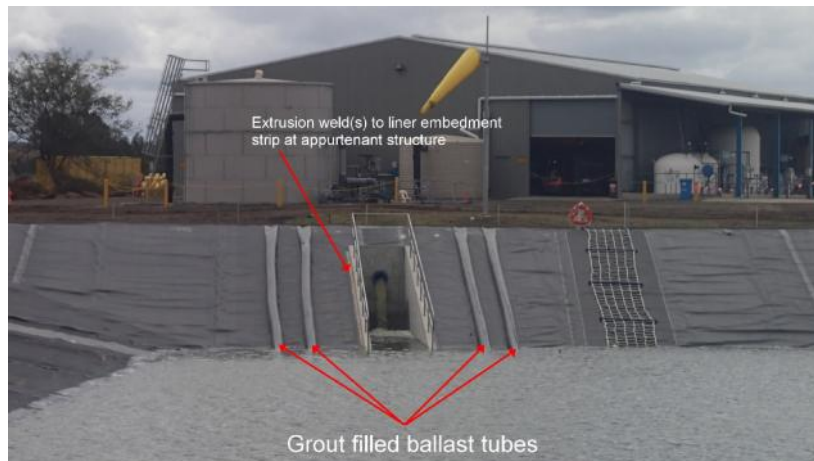
Figure 3. Grout filled ballast tubes assisting with minimising stress on extrusion welds to LES

When considering a GMB connection to concrete subjected to a hydraulic head, the detailing and installation of the LES is the most critical component to reduce leakage to acceptable limits. These limits are determined as part of the Action Leakage Rate (ALR) calculated for the liner system. While the LES provides a strong mechanical termination (via extrusion welding), if installed by a lining contractor with prior experience, the connection should also be designed to be as stress free as possible. To assist with mitigating expansion and contraction stresses on the extrusion weld (due to cyclic loading), ballast is required around or alongside the structures, see Figure 3. If the structures will be permanently submerged then ballast may not be required, however, this should be determined specifically for each project.

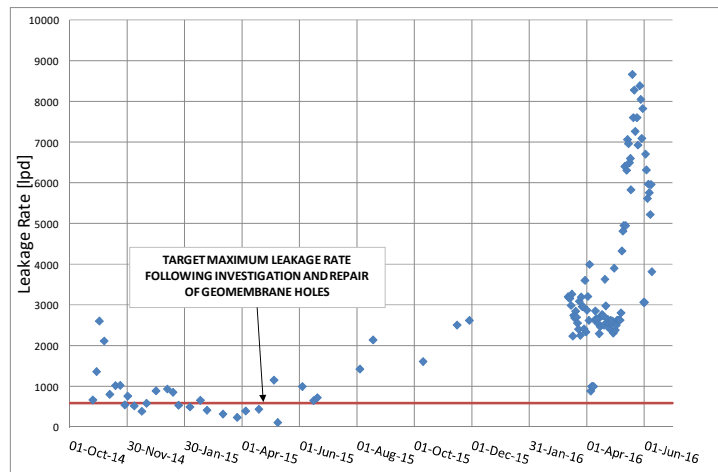
ALRs are used as a trigger value to ensure leakage rates are not allowed to become excessive, thereby protecting the liner system and environment from potential damage or harm. Figure 5 provides example data and shows the importance of leakage rates being monitored during operations. The liner system comprised a HDPE geomembrane (2.0mm thick) overlying a herringbone arrangement of geocomposite drainage strips placed on a clayey subgrade.

Figure 5. Plot of leakage rate versus time and an example of measured leakage rate exceeding design leakage rate

The ALRs provide criteria for asset operators to evaluate the performance of the installed liner system and triggers corresponding action plans if performance goals are not met. It is recommended that the asset owner is involved with the assessment of ALRs as it becomes their responsibility to monitor leakage and undertake appropriate actions if trigger levels are exceeded. The technical understanding of ALRs and the identification of the causes of excessive leakage form the essential background to cost-effective measures to reduce the risk of failures. While physical or intrusive investigations have an important role, regular inspections and monitoring of instrumentation with the knowledge of how to respond (i.e. having a trigger action response plan in place) can provide an essential component in developing this understanding. During the condition assessment of a leaking liner system, the performance history of the liner system is one of the most useful and important elements in identifying potential issues at an early stage and making an accurate diagnosis of the problem.

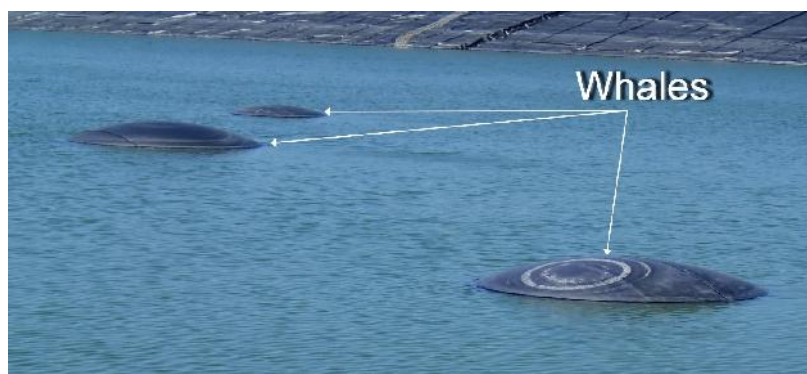
Typically, a whale contains gas above the water/liquor line and water/liquor beneath the GMB if the GMB is leaking due to defects (e.g. small holes, defective welds). Typically, the GMB will have a lower density than the stored liquor, so it will float. This will lift the GMB off the subgrade (or underlying geosynthetic layer), breaking the intimate contact, resulting in an increased leakage rate. The stressed GMB forms a bubble-shaped feature which is termed a 'whale' as it looks like the back of a whale above water level, as shown in Figure 6. GMBs with many defects are more susceptible to developing whales.

Figure 6. Examples of whales with trapped gas and liquid beneath the GMB

The objective of this study was to determine the root cause and mechanism of whale failures in the HDPE GMB that formed part of a temporary liner system (refer to Figure 6.) There were at least four known whales where the GMB had ruptured based on evidence provided by the client and inspection/retrieval of the failed GMB samples from the dam. Visual inspection suggested that the failure mode was by 'necking' (i.e. multiaxial tensile deformation associated with large strains and thinning of the material) until holes/tears appeared, allowing the gas to escape. These holes/tears increased the leakage rate.

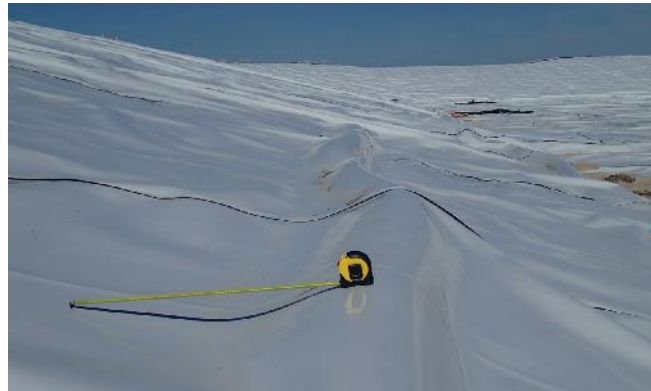
Figure 9 depicts a wrinkle formed in white on black, conductive, 2 mm thick HDPE GMB. The photo was taken around 3:40pm and the ambient temperature was approx. 36°C (location is Western Queensland, Australia). The wrinkle height was approximately 300 mm and the underlying geocomposite drain wasn't exacerbating the wrinkle height. Despite the wrinkle LIT was still possible because the GMB was a conductive liner.

Figure 9. Wrinkle in white conductive GMB

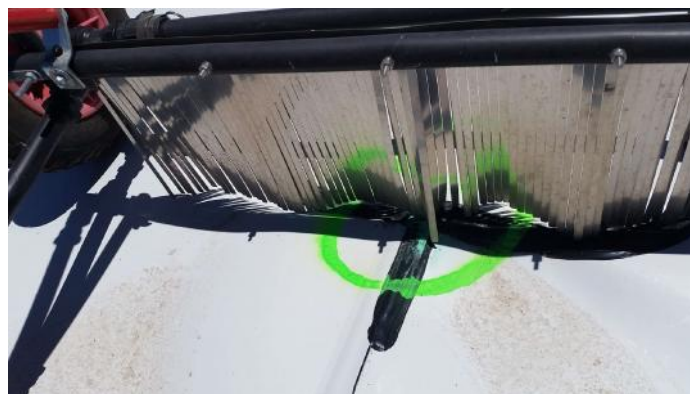
In the past two decades, LIT technology has advanced significantly. Today, LIT can be performed on a bare GMB, on a GMB under water, or on a layer of soil overlying a GMB. The latter is still very dependent on there being intimate contact, hence why conductive backed GMBs should be used if LIT is critical. The LIT equipment can be modified such as that shown in Figure 10 to increase its performance and reduce the physical stress on the operators. This modification assists with articulation over wrinkles, ridges and extrusion welds facilitating a better outcome through strict quality control.

Figure 10. Modified LIT equipment
