## Emergency recovery of Macumba Beach, Rio de Janeiro – RJ, using synthetic structure composed of tubular and flat textile bags.

### ABSTRACT

This paper describes the works carried out in an emergency recovery on the Macumba beach in Rio de Janeiro/RJ. The degradation of the area started after the El Niño and La Niña effects in previous years, caused a strong change in the sea currents regime, leading to excessive beach sand removal, and causing damages to the buildings along the beach in 2017. A protection and erosion control structure was installed as an emergency measure. The structure was constructed with layers of geotextile tubes on top of a concrete geotextile mattress. The tubes were made of woven geotextile fabric filled with colloidal grout, while the mattresses were made of woven and non-woven geotextile fabric filled with sand or grout. The construction was divided in 3 sections along the beach. For every section, geotextile mattresses were laid at different elevations, and the technical specifications of these mattresses varied as a function of elevation and geometry of the beach in that section. At the end of the implementation of the synthetic structure, a backfil

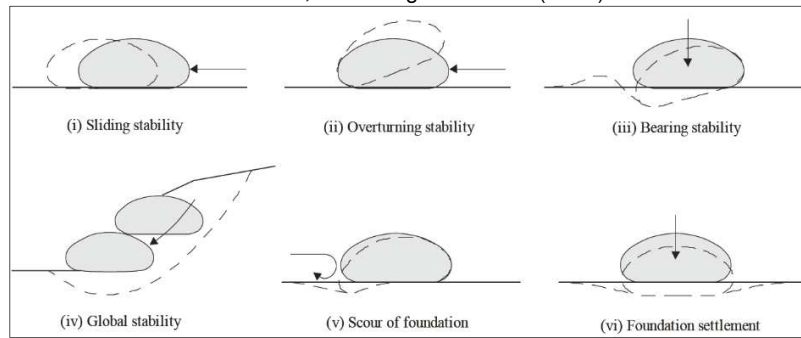
Figure 4 – External failure mechanisms (from adapted from Lawson, 2006).

Figure 4 shows mechanisms of external failure, according to Lawson (2006).

The external failure mechanisms are linked to the boundary conditions in the installation area. The sliding stability (i) was controlled with the temporary frames and the confining of the structure between the coast and the existing buildings. Overturning stability (ii) and Global stability (iv) were guaranteed by the stacking geometry in a pyramid shape. Bearing stability (iii), To avoid Scour of foundation (v) and Foundation settlement, an anti-scour mattress was placed.

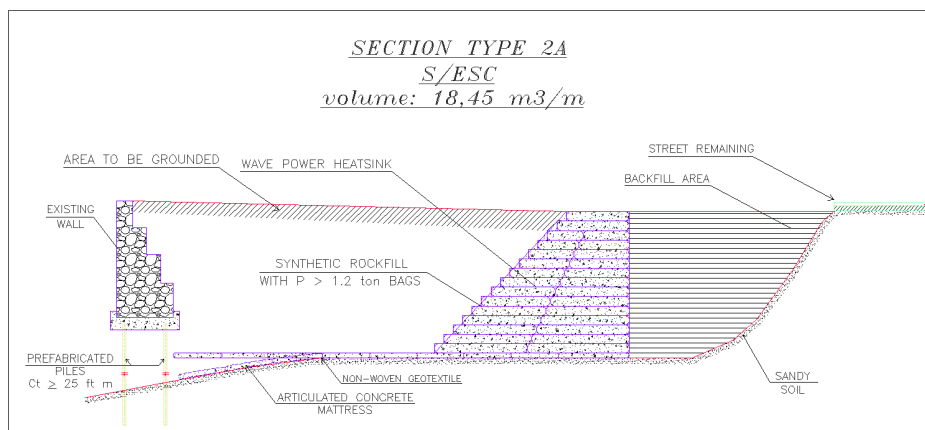
Figure 7- Section 2A - Macumba Beach - Rio de Janeiro / RJ

#### 2.2.2 Type 2A Section - 160m stretch along the beach, as shown in Figure 7.

For the types 2A and 3 sections, to guarantee the stability of the synthetic structure foundation, geotextile mattresses filled with grout were installed, representing the concept of articulated concrete mattress, which perform the function of dissipating stresses throughout the mattress, thus avoiding differential settlements and also providing protection against the scour of the structure, since the mattress allows a certain movement of adaptation to small deformations in the free area (mattress area without the positioning of bags).

Unlike Type 1 Section, in this case a flexible flat shape made with a double layer of geotextile fabric connected by spacers that determine the thickness of the fill was installed. The mattress has a filling height of 0.2 m, allowing a dissipation capacity according to the energies imposed by the structure on the base. The concept of installation at the minimum tide level was guaranteed, preventing the base of the structure from being solicited.

The executive procedure follows the same standards presented in section 2.2.1, changing only the material of the third stage of execution, and the mattress made with non-woven geotextile being replaced by the mattress made by articulated woven geotextile.

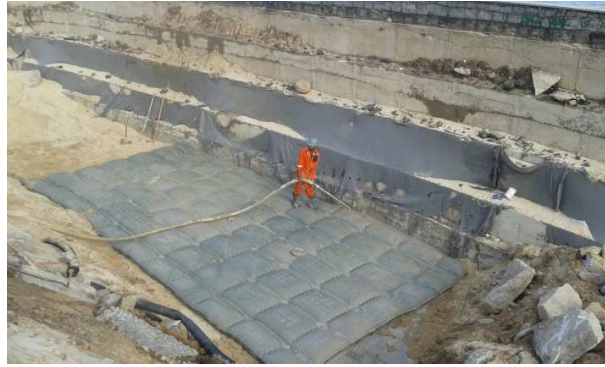
Figure 8 - Mattress filling with the concept of articulated concrete mattress – Macumba Beach – Rio de Janeiro

Figure 8 presents a picture of the mattress filling with the concept of articulated concrete mattress.

This solution is similar to that used in Section 2 and Section 2A, with the flexible geotextile mattress and the tubes made of woven geotextile, as shown in Figures 8. The flexible mattress and tubes filled with colloidal grout with a fck of ~ 20 Mpa were used to perform the function of protection and erosion control.

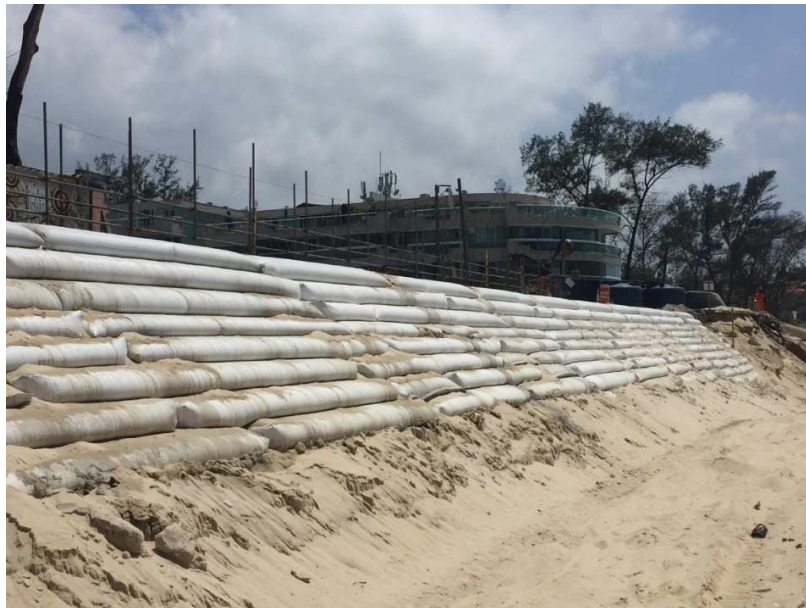
Figure 11 - Section 2A - Macumba Beach - Rio de Janeiro / RJ

Figure 11 shows the synthetic structure in the finished Type 3 Section, ensuring the protection of buildings on the beach.

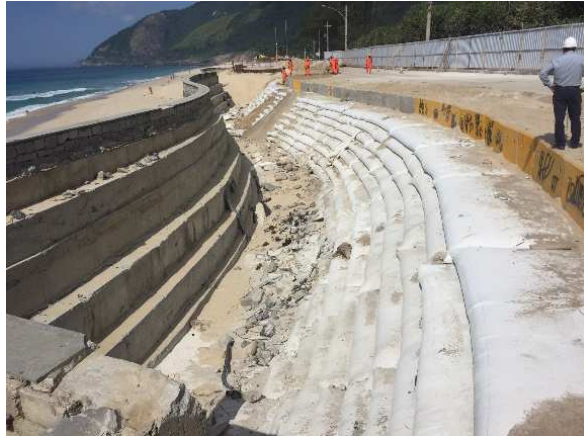
Figure 12 - Type 3 Section - Macumba Beach – Rio de Janeiro / RJ

At specific locations, where there was an existing wall, smaller modules were used, being adapted to the spaces and angulation of wave energy dissipation, as shown in Figure 12.

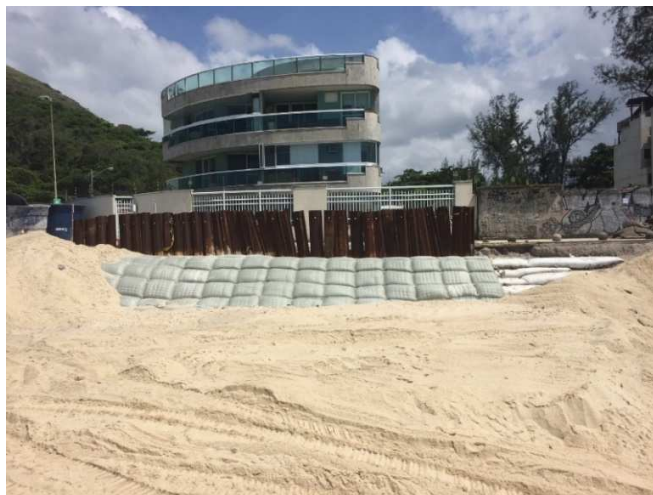
Figure 13 - Protection of foundation - Praia da Macumba - Rio de Janeiro / RJ

In about half of the work, it was necessary to perform a protection of the foundation of a specific building, which presented greater damages and consequently greater risks. As a punctual work solution, metal piles, Jet Grouting columns, geotextile tubes and flexible geotextile mattresses were used, limiting the structural damage to the building, caused by wave actions, as shown in Figure 13.
