Evaluation of geomat physical properties after 6 years submitted to the real field conditions in the of Arroio Passo da Mangueira channel.

The channel works was constructed as a superficial revetment and protection of the Arroio Passo da Mangueira banks. The channel solution was used in the lower part (1/3 of the height), and the base of the bank was used gabion mattress with concrete. For the rest of the bank it was adopted an application of geomats for control erosion, with grassy vegetation grouped with other vegetations of 50mm until 150mm of height. After six years of the application, were made tests with the material to verify the degradation of the phisycal properties of the geomat submitted to the reals conditions. In this case, was noted a small physical degradation of the geomat, and the bank presents a excellent natural coverage.

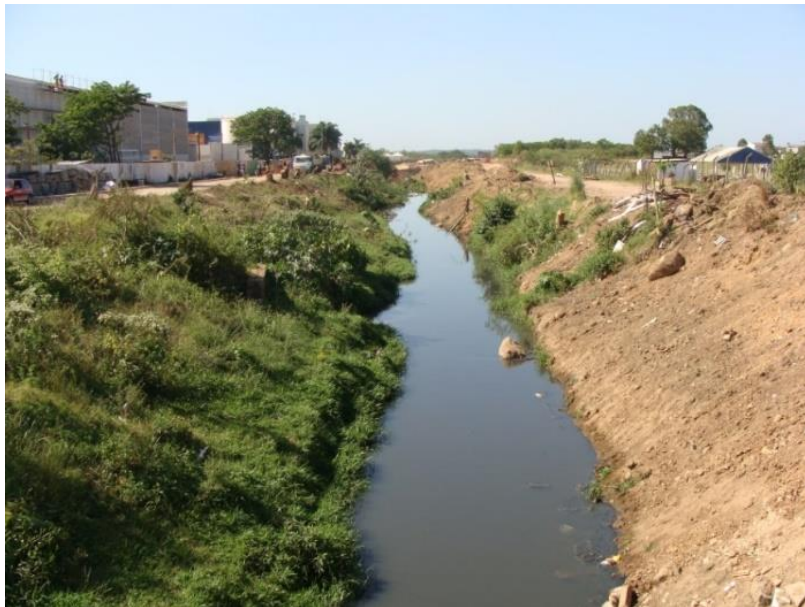
Figure 2. Current situation of the Passo da Mangueira initial stretch of the on Rua Dona Alzira, Porto Alegre.

Along the stretch, for the intervention, it was possible to observe that the local soil was heterogeneous and composed, in general, of a layer of sandy-silty embankment and a layer of sandy clay (figure 2). The clay layer showed dissection cracks and localized instability. the embankment slope suffered an erosive process at its base, which could start a global rupture.

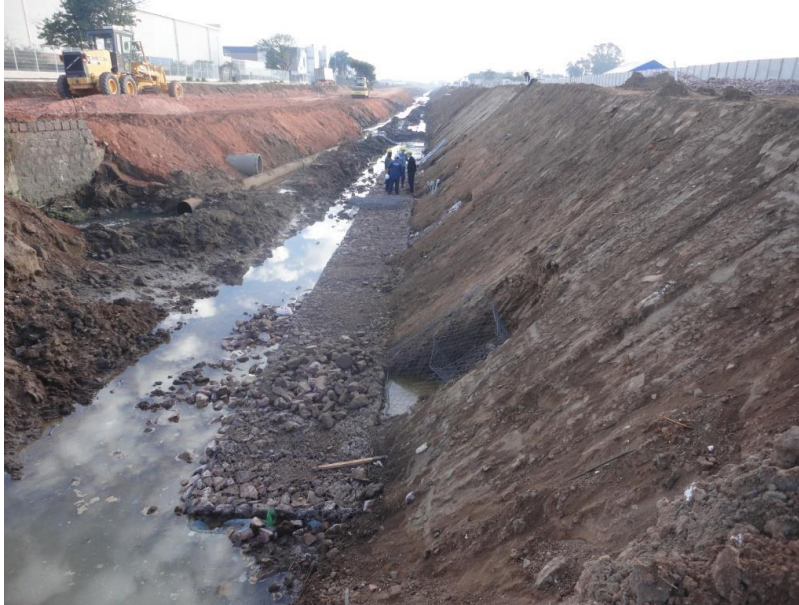
Figure 4. Regularized slope

For the geomat execution the first step was to clean the slope by removing trunks, boulders or any obstacle that could obstruct the coils of the geosynthetic, making it uniform and regularizing it. This cleaning was performed with the aid of heavy equipment and with subsequent manual thinning. In Figure 6, it is possible to verify the regularized slope and the beginning of the execution of the coating in mattress-type gabions at the base of the channel gutter.

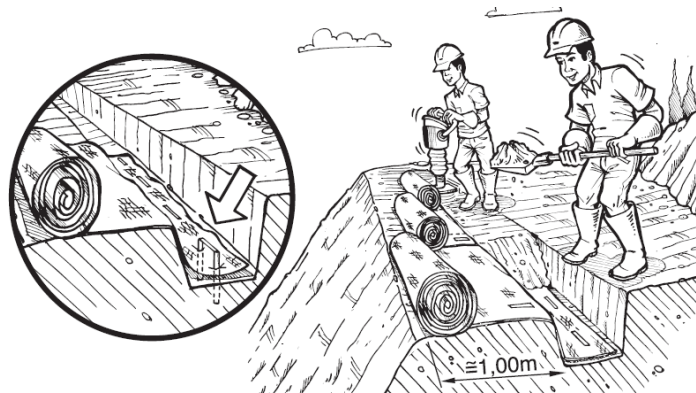
Figure 5. Anchoring trench

Prior to the installation of the geomat, a channel was spaced at least 1.0m from the top of the slope, with the main function of anchoring the geomat on the slope in addition to being also responsible for the upper drainage (Figure 5).

The channel was executed before the development of the geomat over the slope, with a height and depth of 0.30m, and with the same longitudinal extension of the section to be protected. The upper end of the geomat was placed inside the channel and fixed with clamps. After the first fixation of the geosynthetic, the channel was filled with the soil that was removed from it and compacted manually.

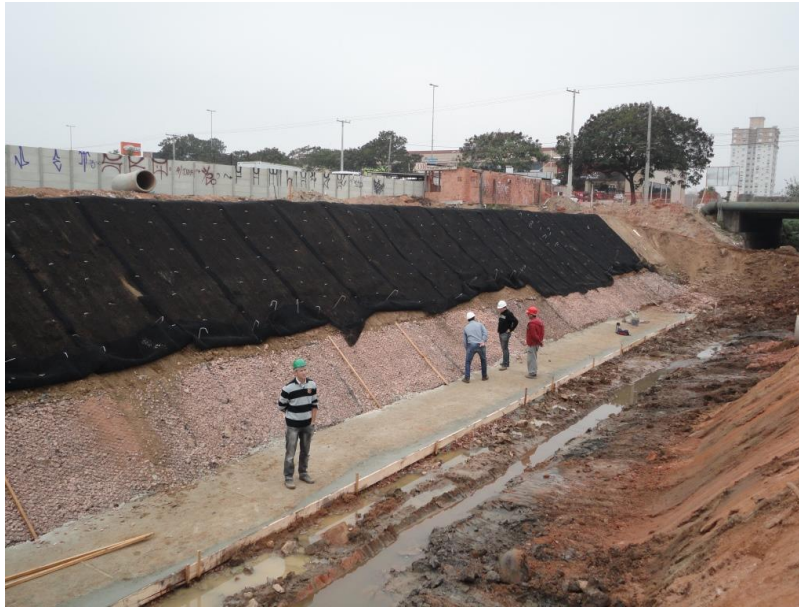
Figure 6. Geomat application

Once anchored, the geomat is unrolled from top to bottom and with 30 cm overlaps at the ends of the rollers (Figure 6).

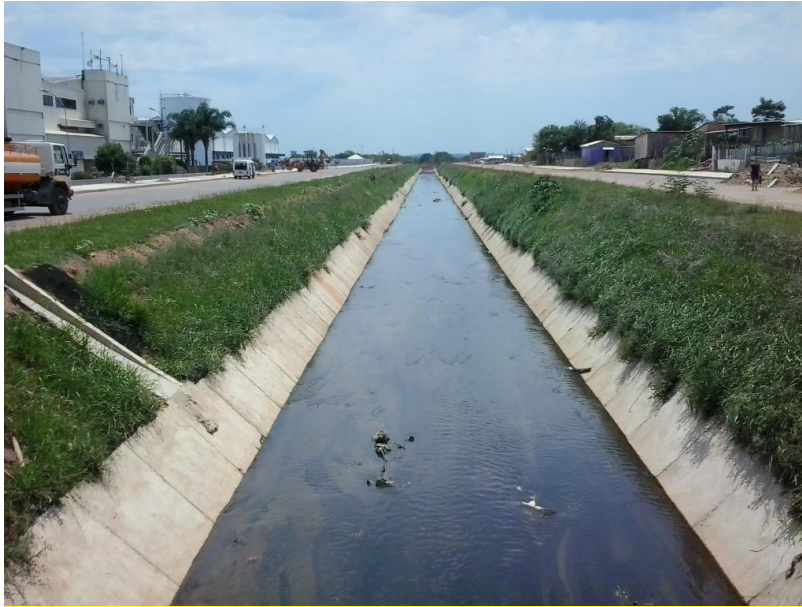
Figure 9. View of the work completed in August / 2014.
