Irrigation Canals Lining: Moving from a Short- to Long-Term Effectiveness of Seepage Control with the Use of Geosynthetics

H. Plusquellec, Consultant, USA

E. Blond, Consultant, Canada

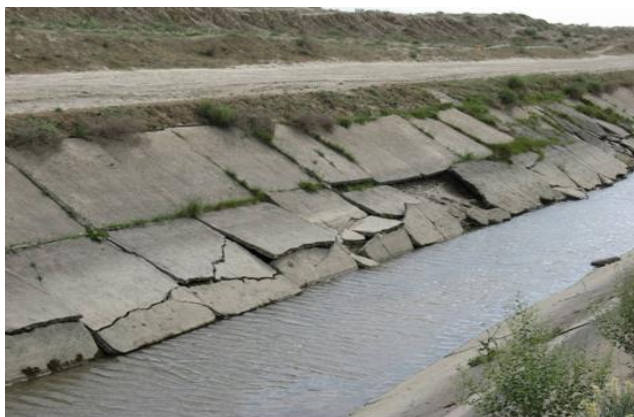
Figure 1. deteriorated rigid (concrete) veneer liner

Concrete lining has historically been the preferred method of lining by many irrigation agencies. Brick layers have been frequently used in countries with cheap labor cost, such as in the Indo-Gangetic alluvial plain in India and Pakistan. Concrete as a lining material, can theoretically last up to 50 years under high quality of design and construction, without physical failure. However, there are now strong theoretical and field evidence that a majority of hard (i.e. concrete) surface linings deteriorate within a few years following their installation, to the point where seepage losses of the canals are as high as before the concrete liner was installed.

Cracks are typically caused by change of morphology of the subgrade, and develop on concrete-lined canal slopes under certain geotechnical conditions and/or harsh climatic environments. Soils with high plasticity, subject to swelling, as well as gypsum and collapsible soils are the most likely to generate differential settlement of the sub-base. Frost heave is a major cause of cracking in areas exposed to long periods of below-freezing temperatures. Finally, quality of construction, such as poor compaction of embankment and poor vibration of concrete, is also a frequent cause of rapid deterioration of the concrete veneer, therefore of the effectiveness of the seepage control.

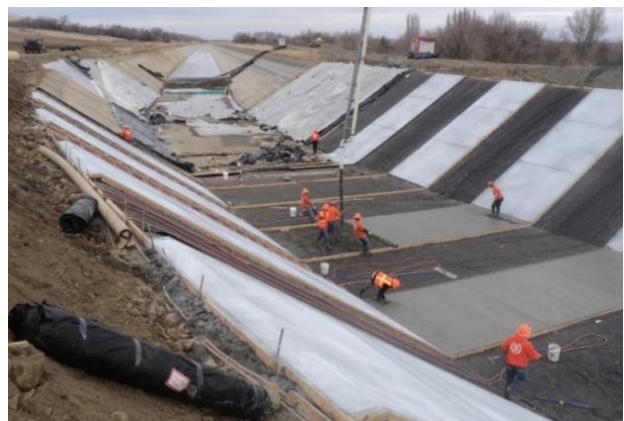
Figure 2: Installation of concrete on a geomembrane
